**AFTER ACTION REPORT
FOR
DAM BREACHING**

**Pigg River Power Dam
Franklin County, Virginia**

January 2018

Prepared by:
David Byrd
Coordinator, Virginia Partners for Fish and Wildlife Program
U.S. Fish and Wildlife Service
6669 Short Lane

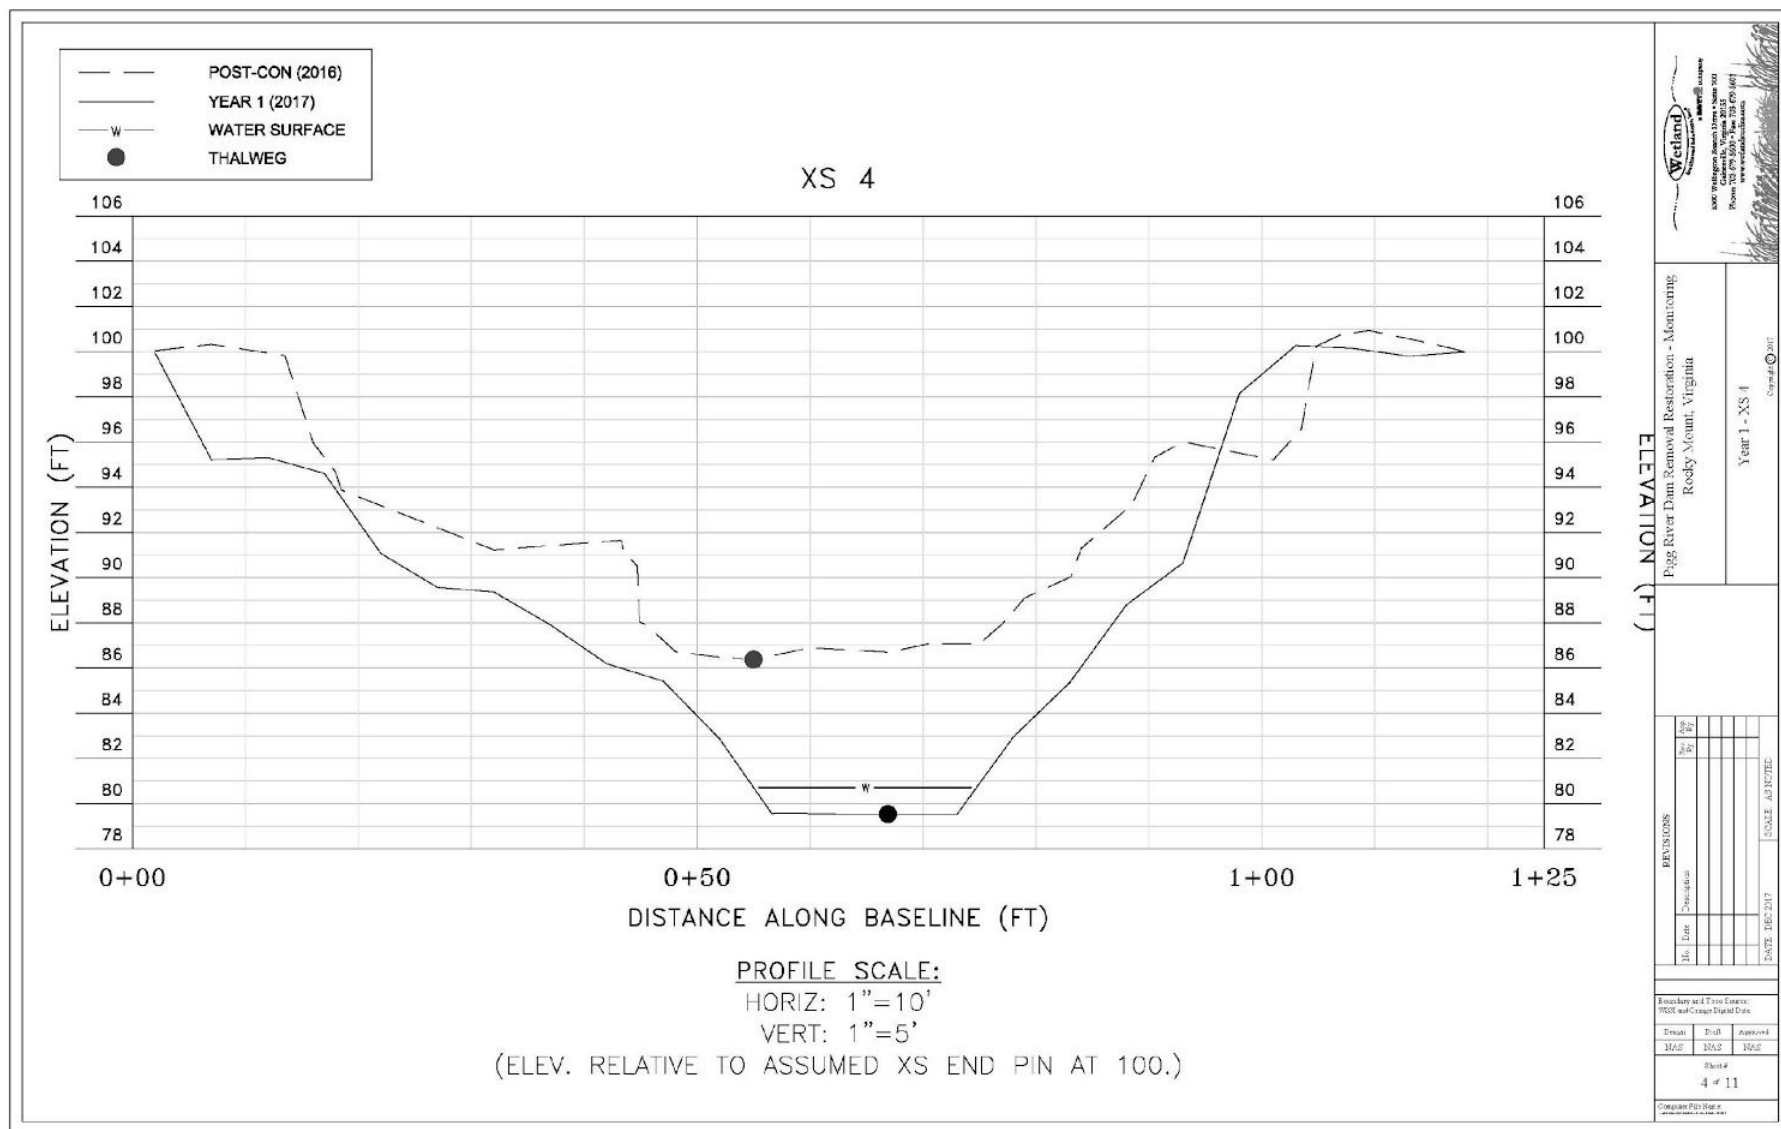
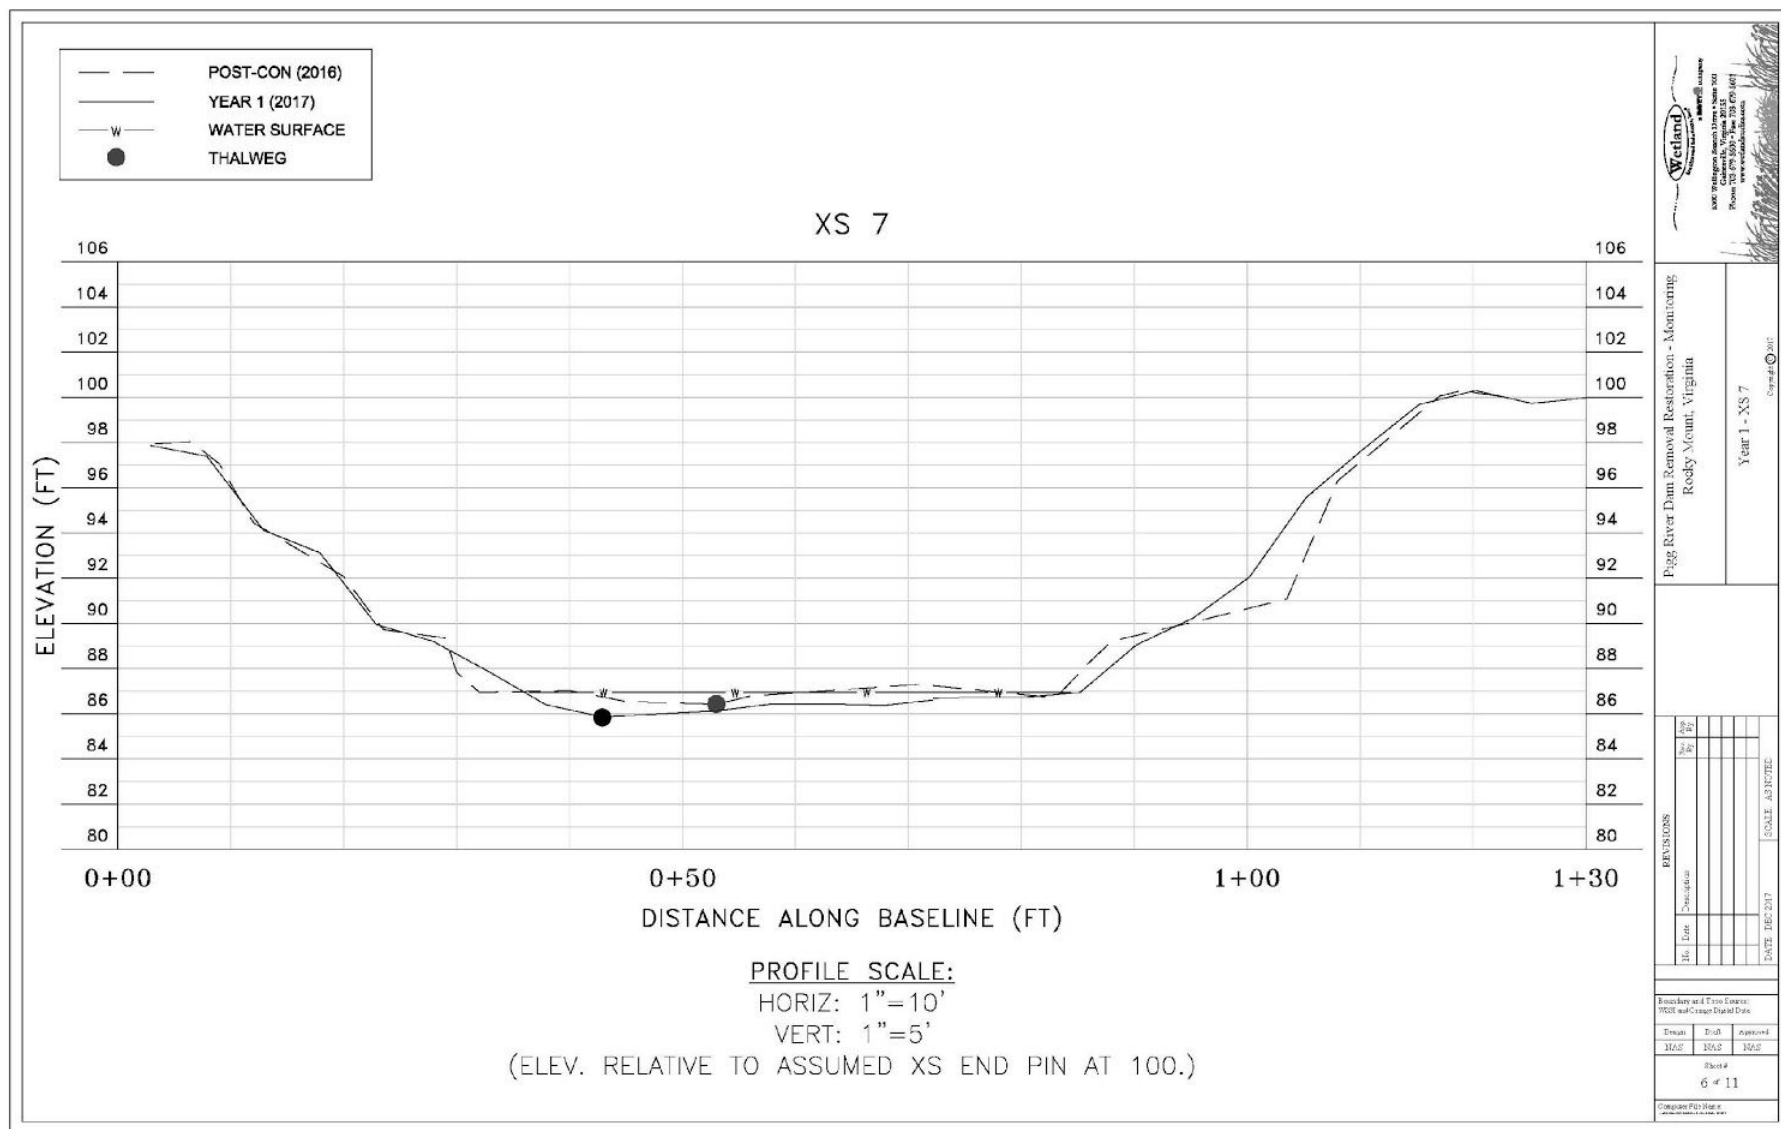
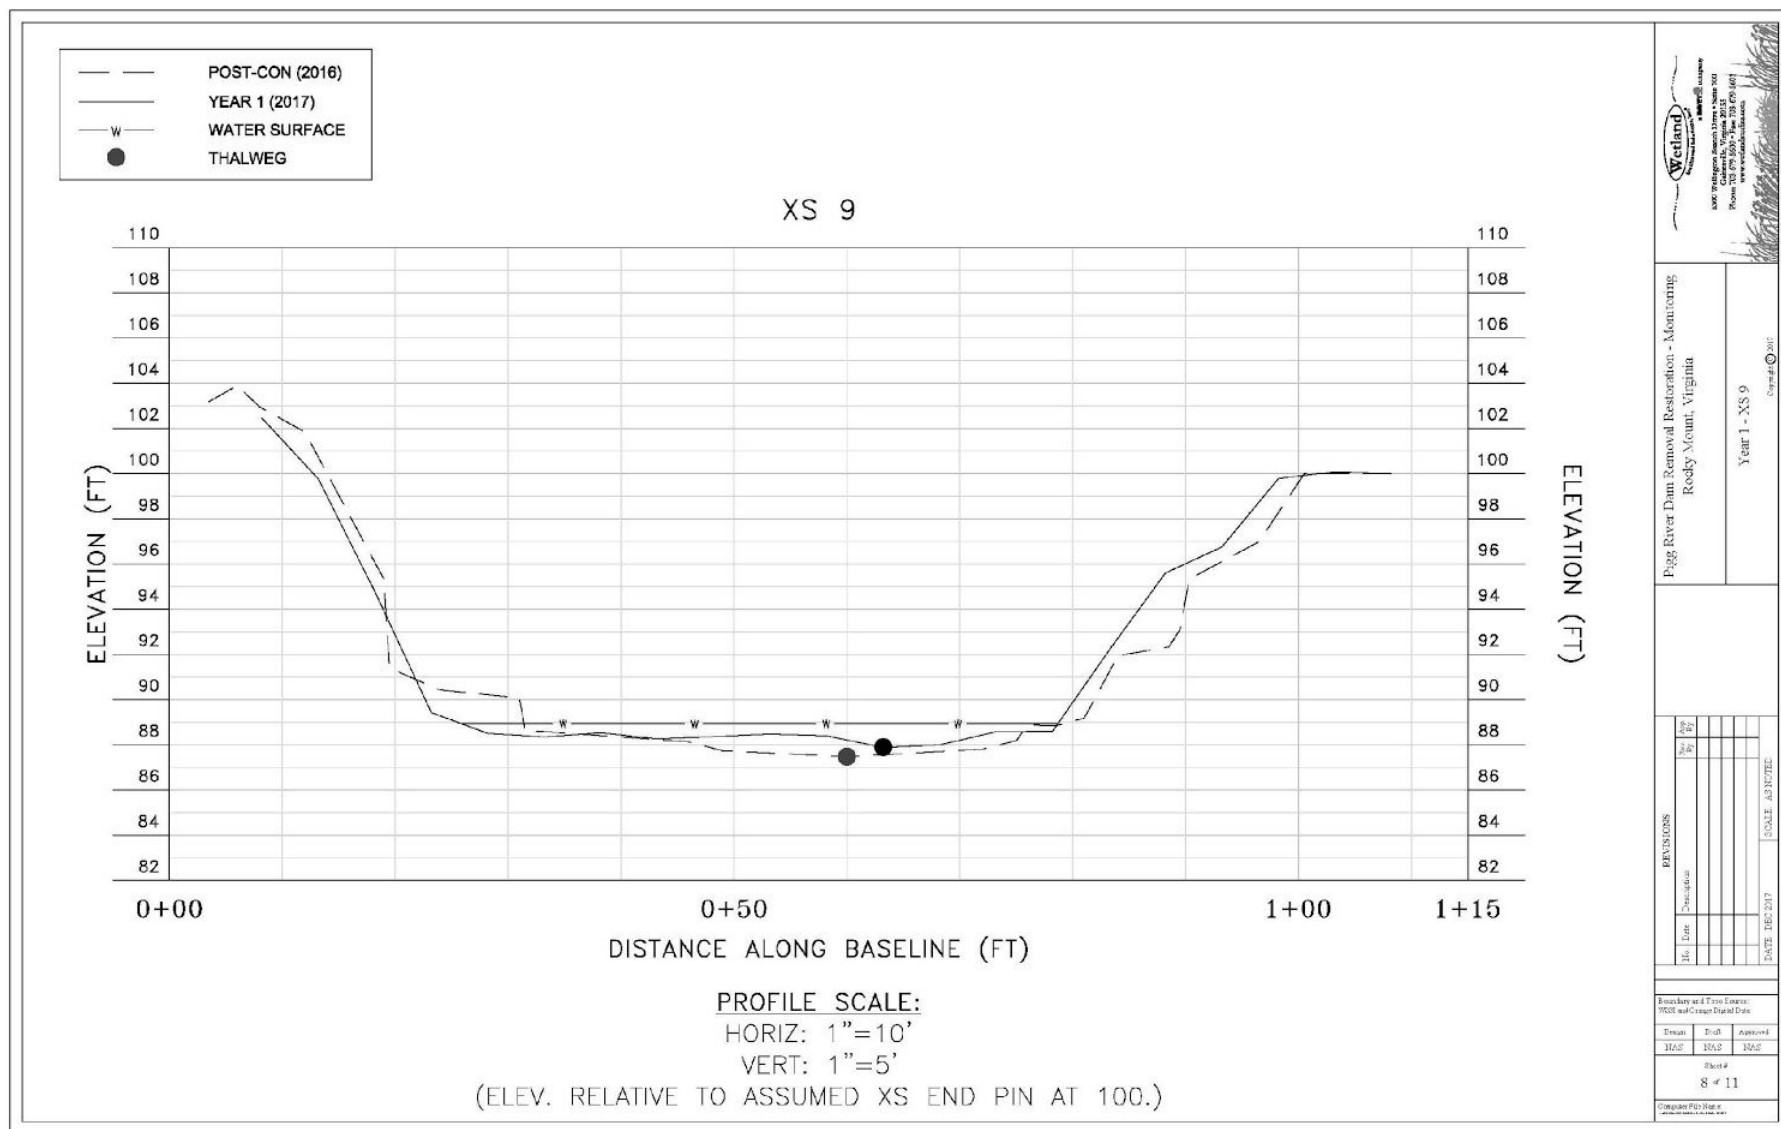
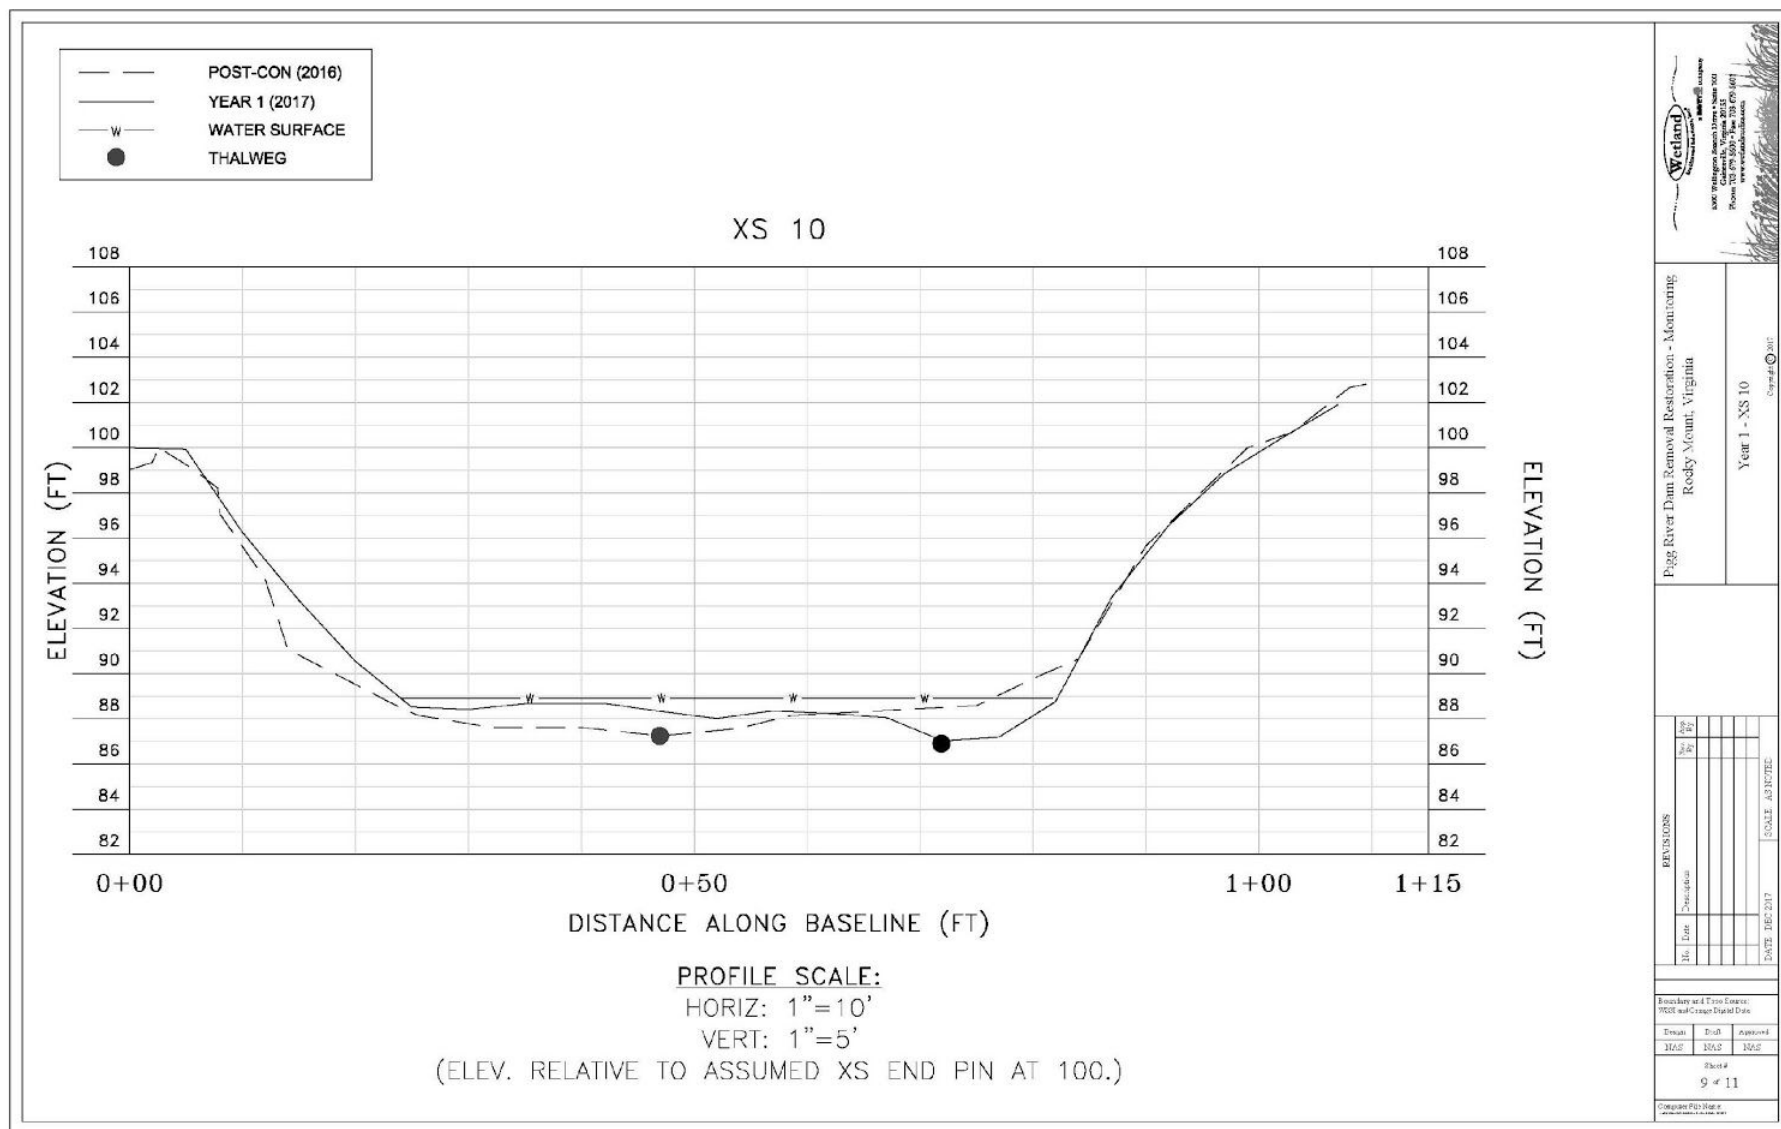
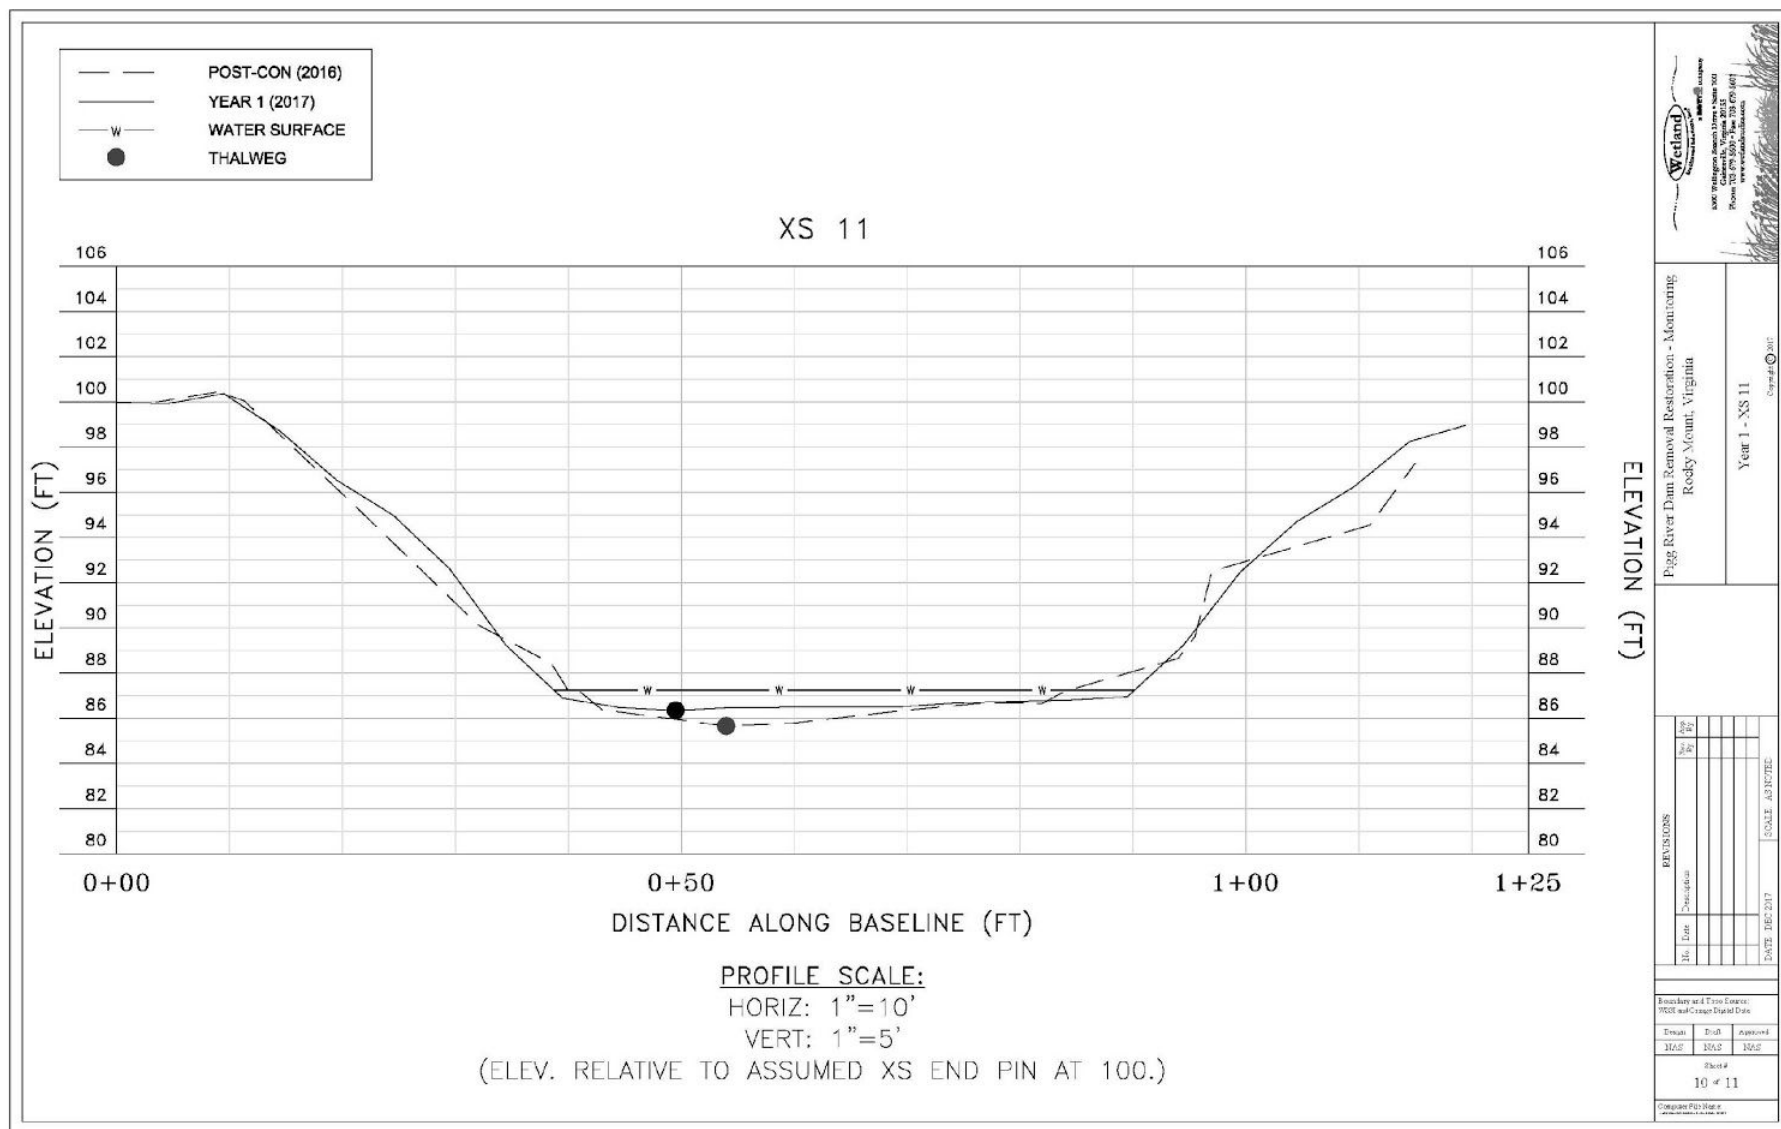
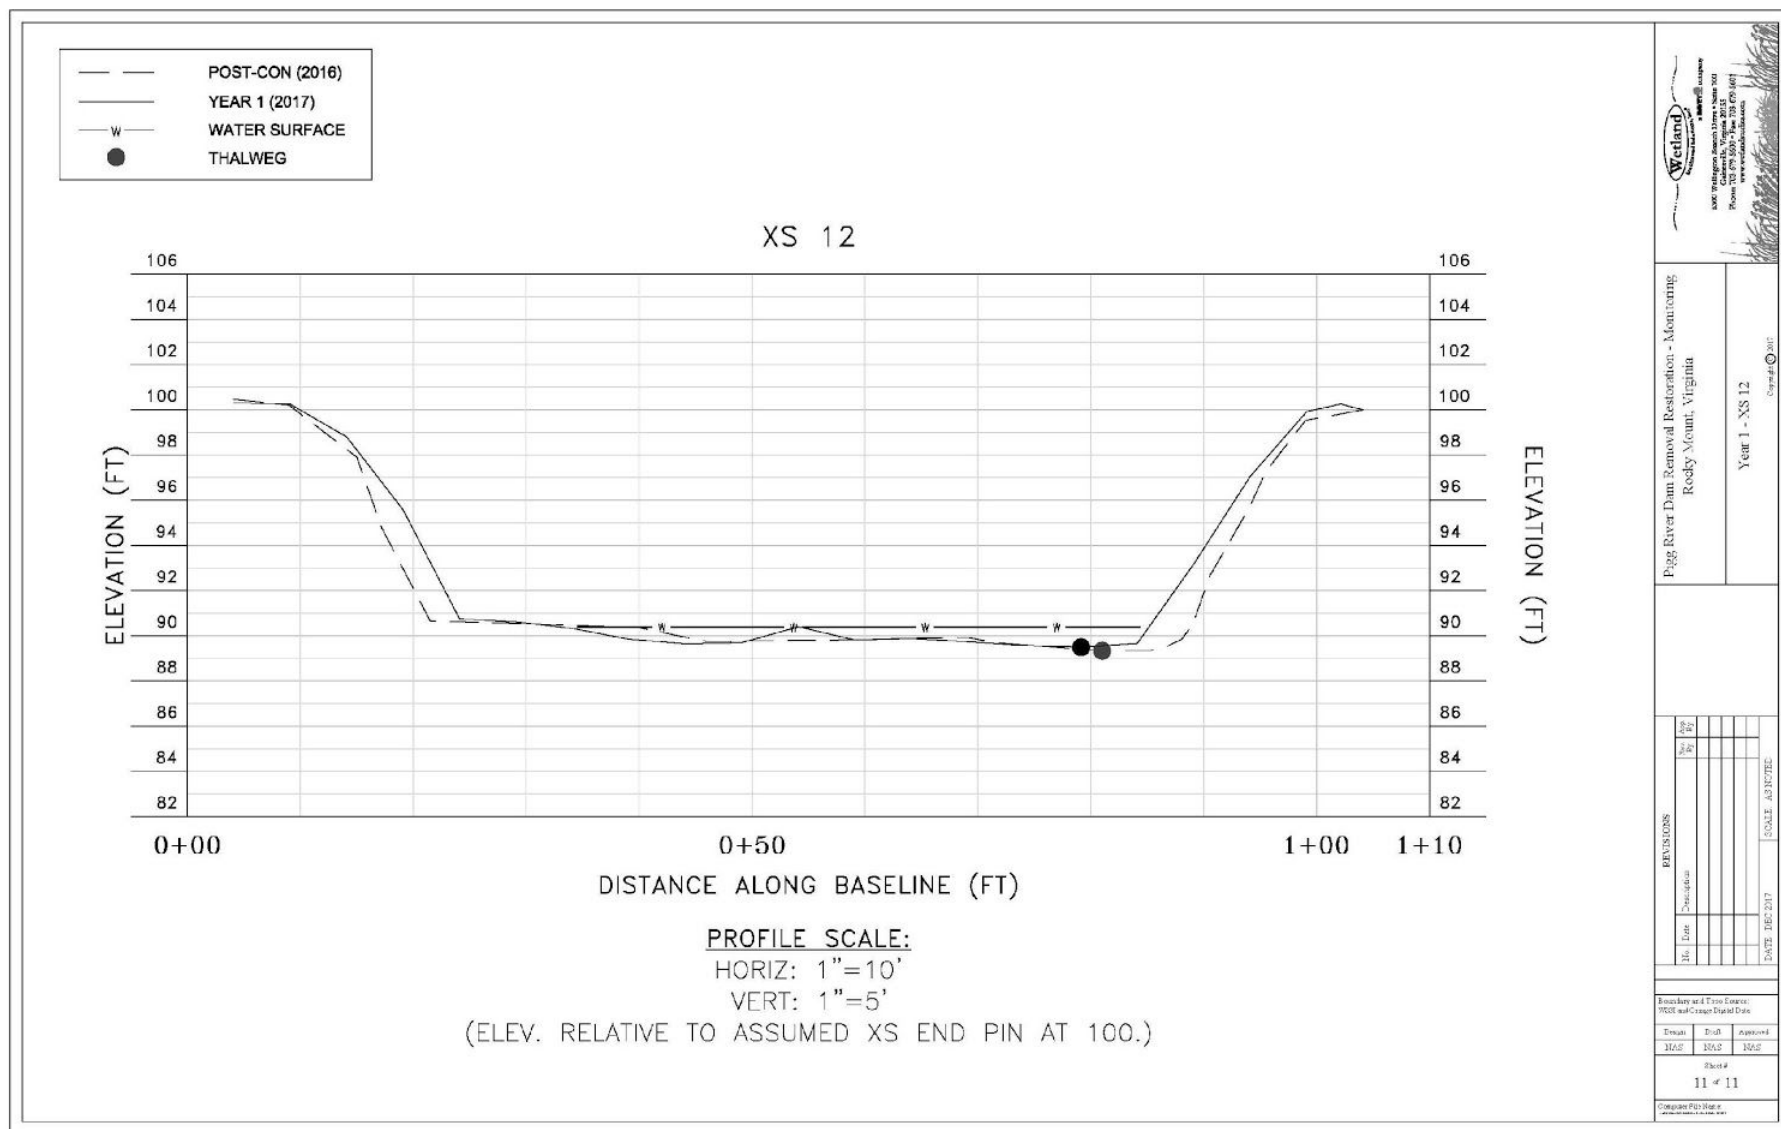
Pre- and Post-Construction Cross Sections

A comparison of cross section surveys between Year 0 and 1 (Appendix B) shows slight streambed incision of approximately 1 ft at Cross Section 1, upstream of the former pool extent with increased degradation (downcutting) in Cross Sections 2-4 ranging from 2 to 7 ft at Section 4, approximately 0.8 mile upstream of the dam. Changes in channel cross sections at Sections 5 and 6 (0.37 and 0.05 mile, respectively) were less significant as a result of channel evolution that occurred between completion of dam breaching activities and post-construction monitoring when significant high flow events occurred. Colonization by herbaceous vegetation has provided stabilization in those areas where banks have ceased significant mass wasting. However, tension cracks are visible at cross sections where steep banks still exist and are exhibiting signs of mass failure (WSSI 2017).
